## Nuclear Cryogenic Propulsion Stage (NCPS) Fuel Element Testing in the Nuclear Thermal Rocket Element Environmental Simulator (NTREES)

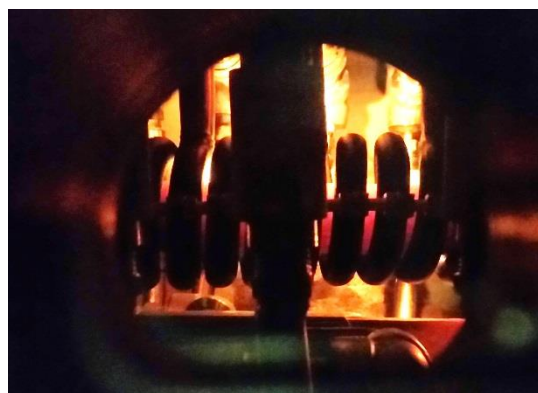
Figure 3 Fuel Element at Nominal Power

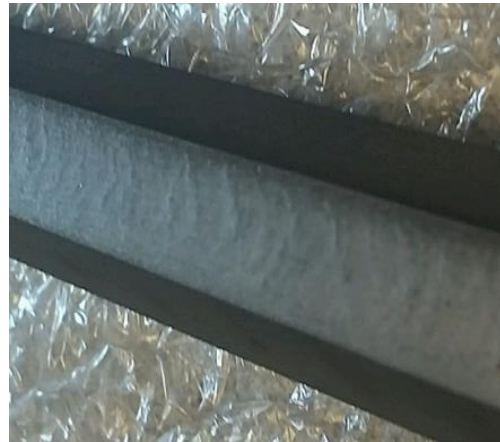
During the testing, the fuel element behaved as expected indicating that it likely survived the nominal testing conditions intact thus meeting all the predetermined project objectives. After the test concluded, the NTREES test chamber was depressurized and the fuel element allowed to cool to room temperature. The NTREES test chamber was then opened up and the fuel element removed. A visual inspection of the fuel element confirmed that no damage had occurred to the fuel element thus satisfying testing milestone required by the NCPS project. Figure 4 illustrates the condition of the fuel element after the test was completed. Note that the surface shows no obvious signs of damage.

Figure 4 Testing Shows No Visible Damage

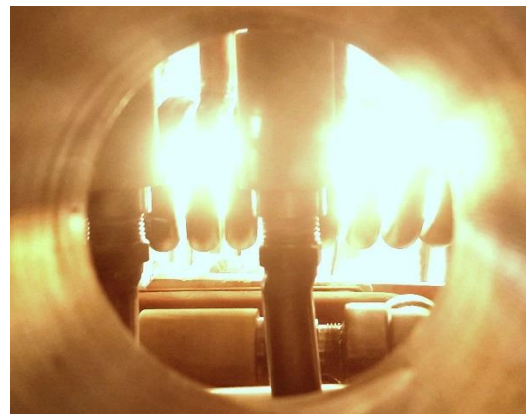
Figure 5 Fuel Element at Maximum Power

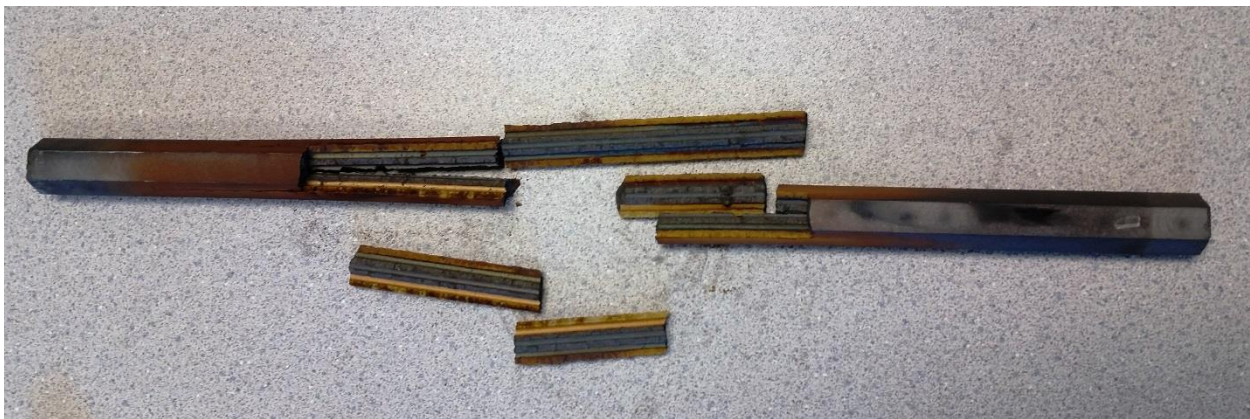
During this testing, the fuel element was above 2800 K for almost 4.5 minutes and was above 2500 K for over 8.5 minutes. The 2800 K temperature in the fuel element was achieved at an induction power level of approximately 169 kW or at just over 14% of the power available from the 1.2 MW induction heating unit. It was noticed near the end of the 4.5 minutes the fuel element was at 2800 K, that the temperature in the fuel element was starting rapidly fluctuate over a several hundred degree range and

generally decrease in magnitude. Simultaneously, the induction power in the induction heating unit started to increase slightly. This type of behavior indicated that fuel element damage was probably beginning to occur. The decision was then made to slowly decrease the induction power in the NTREES induction heater so as to slowly drop the temperature in the fuel element. After about 11 minutes, the induction power level had been reduced to approximately 30 kW and the temperature in the fuel element had been reduced to roughly 1000 K. At this point, the hydrogen concentration level in the chamber spiked significantly resulting in an automatic system shutdown wherein the induction power was cutoff and the main hydrogen inlet valves were closed. System purging with nitrogen was also initiated as a result of the shutdown. The cause of the hydrogen concentration spike was thought to almost certainly be due to the catastrophic failure of the fuel element. Such a failure would cause the hydrogen normally flowing through the fuel element to discharge directly into the NTREES chamber rather than into the hydrogen/nitrogen mixer assembly as would be the case if the fuel element were still intact. Upon removal of the fuel element from the chamber, it was indeed confirmed that the fuel element had failed catastrophically as shown in the post test photograph illustrated in Figure 6. It should be emphasized that the conditions under which the fuel element failed were well in excess of those at which fuel failure was expected to occur and demonstrated considerable robustness in a very preliminary fuel element configuration.

Figure 6. Failed Fuel Element from NTREES Test at 2800 K
