## Nuclear Cryogenic Propulsion Stage (NCPS) Fuel Element Testing in the Nuclear Thermal Rocket Element Environmental Simulator (NTREES)

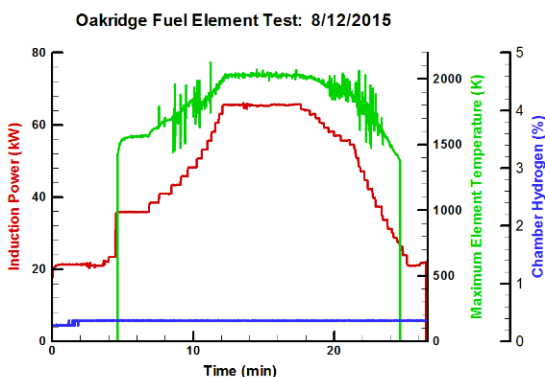
Figure 2 Nominal Test Conditions

The testing began by loading the fuel element into NTREES and subjecting it to an axial loading of approximately 35 pounds. The NTREES chamber was then closed and the atmosphere was inerted with nitrogen gas and pressurized to approximately 200 psig. A hydrogen flow through the fuel element was then established at approximately 1 gm/sec. The induction heater was then energized and power was applied to the fuel element. The power and maximum temperature profiles which the fuel element encountered during the test are illustrated in Figure 2. A view of the fuel element at approximately 2000 K is illustrated in Figure 3. The 2000 K temperature in the fuel element was achieved at an induction power level of approximately 65 kW or at just over 5% of the power available from the 1.2 MW induction heating unit.

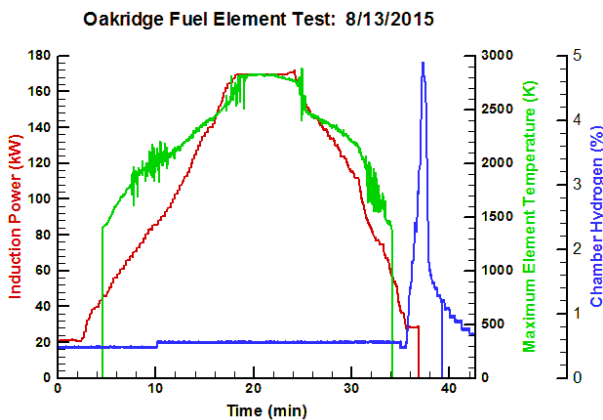
Figure 4 Aggressive Test Conditions

During this testing, the fuel element was above 2800 K for almost 4.5 minutes and was above 2500 K for over 8.5 minutes. The 2800 K temperature in the fuel element was achieved at an induction power level of approximately 169 kW or at just over 14% of the power available from the 1.2 MW induction heating unit. It was noticed near the end of the 4.5 minutes the fuel element was at 2800 K, that the temperature in the fuel element was starting rapidly fluctuate over a several hundred degree range and

generally decrease in magnitude. Simultaneously, the induction power in the induction heating unit started to increase slightly. This type of behavior indicated that fuel element damage was probably beginning to occur. The decision was then made to slowly decrease the induction power in the NTREES induction heater so as to slowly drop the temperature in the fuel element. After about 11 minutes, the induction power level had been reduced to approximately 30 kW and the temperature in the fuel element had been reduced to roughly 1000 K. At this point, the hydrogen concentration level in the chamber spiked significantly resulting in an automatic system shutdown wherein the induction power was cutoff and the main hydrogen inlet valves were closed. System purging with nitrogen was also initiated as a result of the shutdown. The cause of the hydrogen concentration spike was thought to almost certainly be due to the catastrophic failure of the fuel element. Such a failure would cause the hydrogen normally flowing through the fuel element to discharge directly into the NTREES chamber rather than into the hydrogen/nitrogen mixer assembly as would be the case if the fuel element were still intact. Upon removal of the fuel element from the chamber, it was indeed confirmed that the fuel element had failed catastrophically as shown in the post test photograph illustrated in Figure 6. It should be emphasized that the conditions under which the fuel element failed were well in excess of those at which fuel failure was expected to occur and demonstrated considerable robustness in a very preliminary fuel element configuration.
